Final Summary Report
Research Project Agreement No. T9233, Task 41
Seismic Vulnerability of the Alaskan Way Viaduct Phase II

**SEISMIC VULNERABILITY OF THE ALASKAN
WAY VIADUCT: SUMMARY REPORT**

1. REPORT NO. WA-RD 363.4		2. GOVERNMENT ACCESSION NO.		3. RECIPIENT'S CATALOG NO.	
4. TITLE AND SUBTITLE SEISMIC VULNERABILITY OF THE ALASKAN WAY VIADUCT — SUMMARY REPORT				5. REPORT DATE July 1995

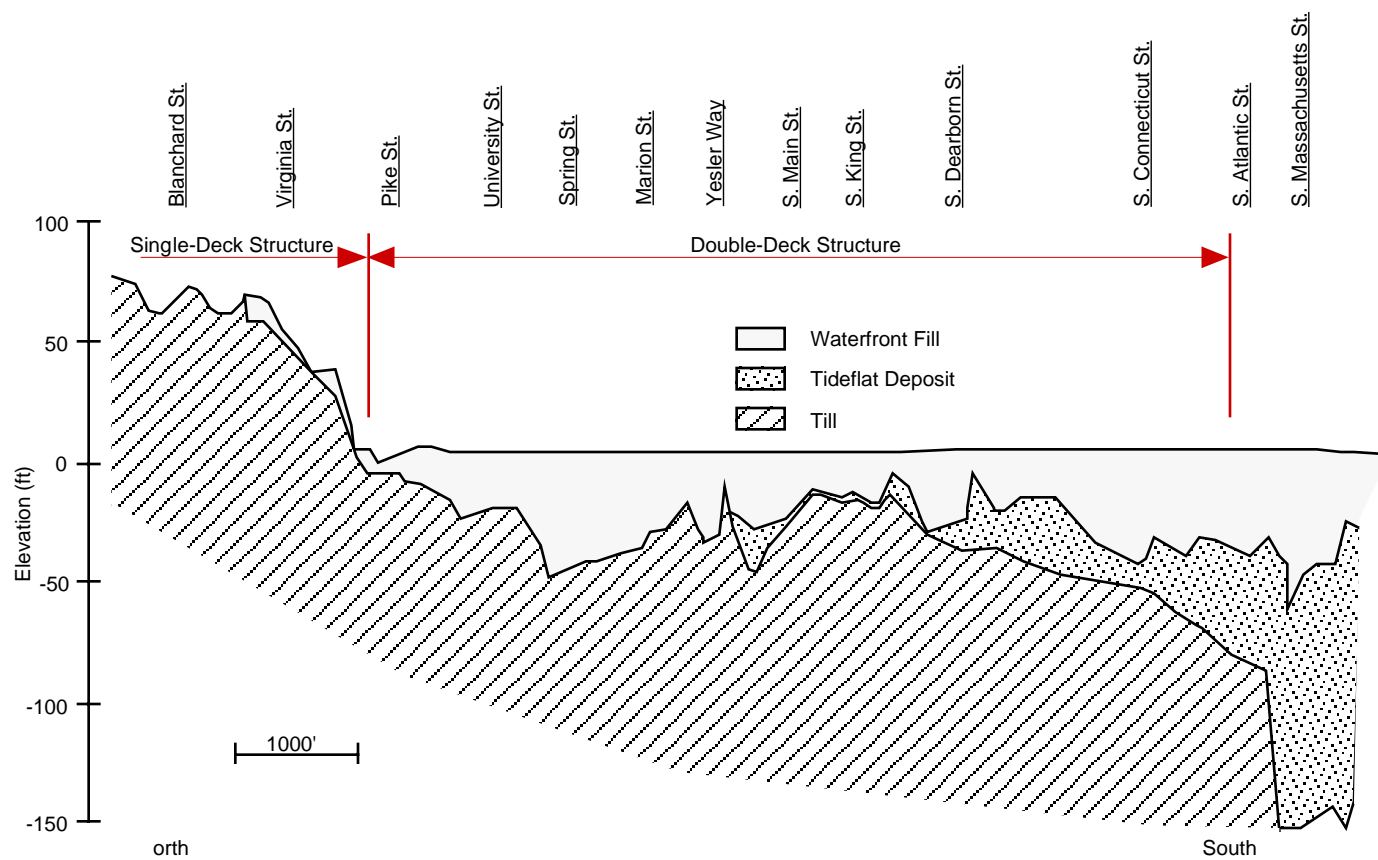
Figure 1. Soil Profile along the Length of the Alaskan Way Viaduct

From the standpoint of geological/geotechnical conditions, the Alaskan Way Viaduct site is dominated by thick deposits of loose, saturated soil. Most of the loose soils were placed as fill during reclamation of the area's tideflats and extension of the waterfront toward Elliot Bay in the late 1800s and early 1900s. Some of the loose soils, particularly those south of about Yesler Way, are natural tideflat soils. The loose soils are underlain by very dense natural soils. The thicknesses of these loose soils vary along the length of the viaduct, as illustrated in Figure 1.

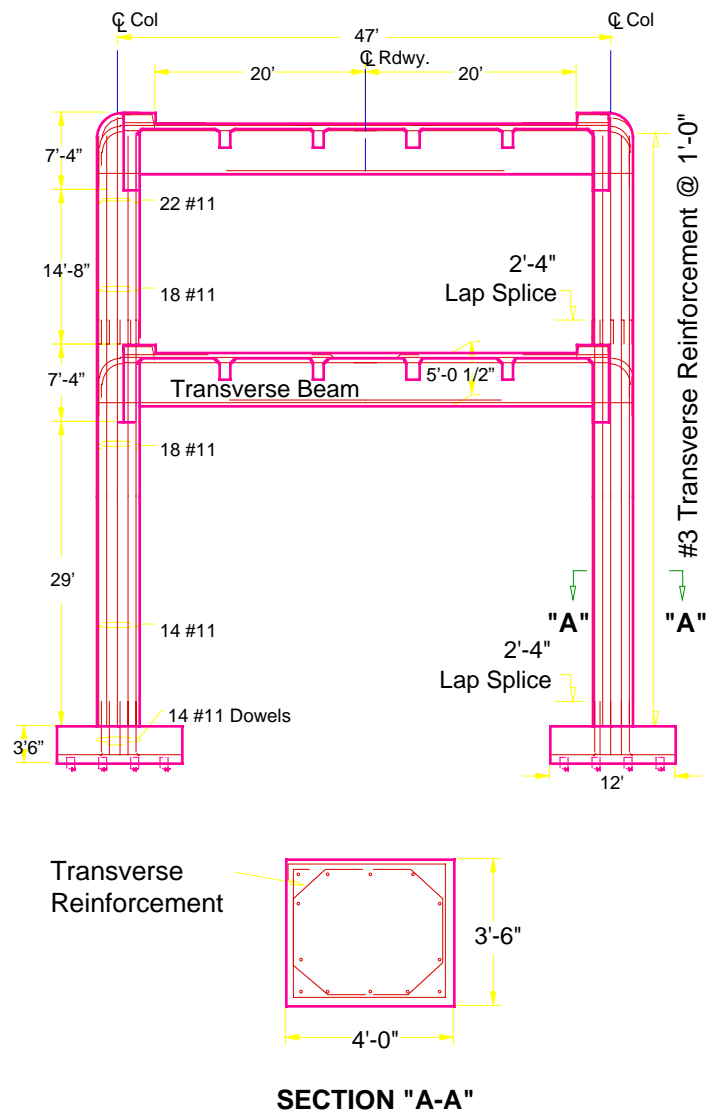
Figure 2. Elevation of Typical Interior Transverse Frame

Another difference between the Alaskan Way Viaduct and modern construction is the presence of longitudinal column reinforcement splices at the column bases and directly above the first deck (Fig. 2). The lap splices are much shorter than those required by current standards, are enclosed by inadequate transverse reinforcement, and

are located in regions that are likely to undergo large flexural demands during an earthquake. Other significant differences between the viaduct and new construction are that the bottom transverse beam and longitudinal girder reinforcement extends into the columns only a short distance, and the footings have no top reinforcement.

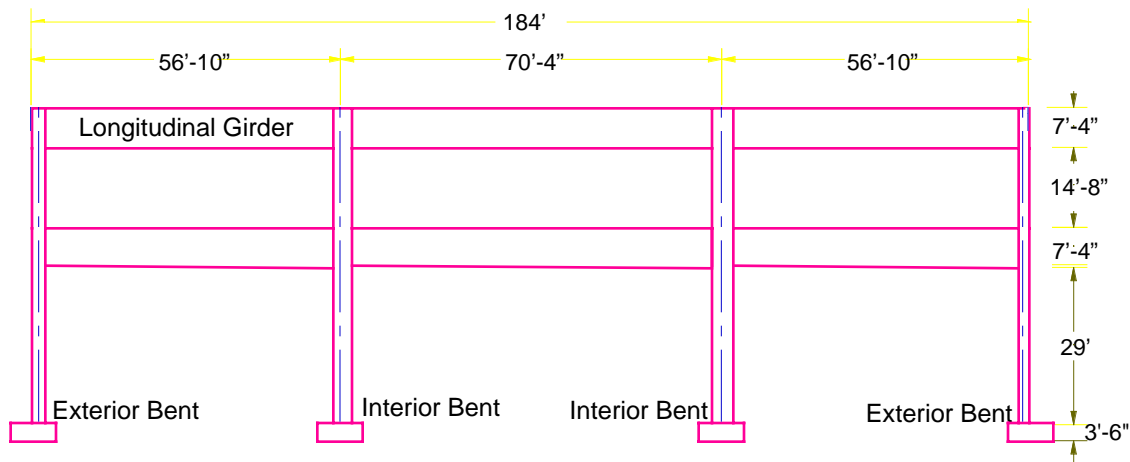
Figure 3. Elevation of Typical Longitudinal Frame

Despite variations to accommodate off-ramps, superelevations and curves, the double-deck portion of the viaduct consists mainly of three-span units that are separated from adjacent units by 2-inch expansion joints. The two decks are supported by beams that run in the transverse direction (perpendicular to traffic) and deep girders that run in the longitudinal direction (parallel to traffic). Unlike many other bridges, the beams and girders frame directly into the columns. In the transverse direction, the beams and columns form four frames that provide the lateral-force resistance of the three-span unit (Fig. 2). The girders and columns form two frames that provide the unit's longitudinal lateral-force resistance (Fig. 3).

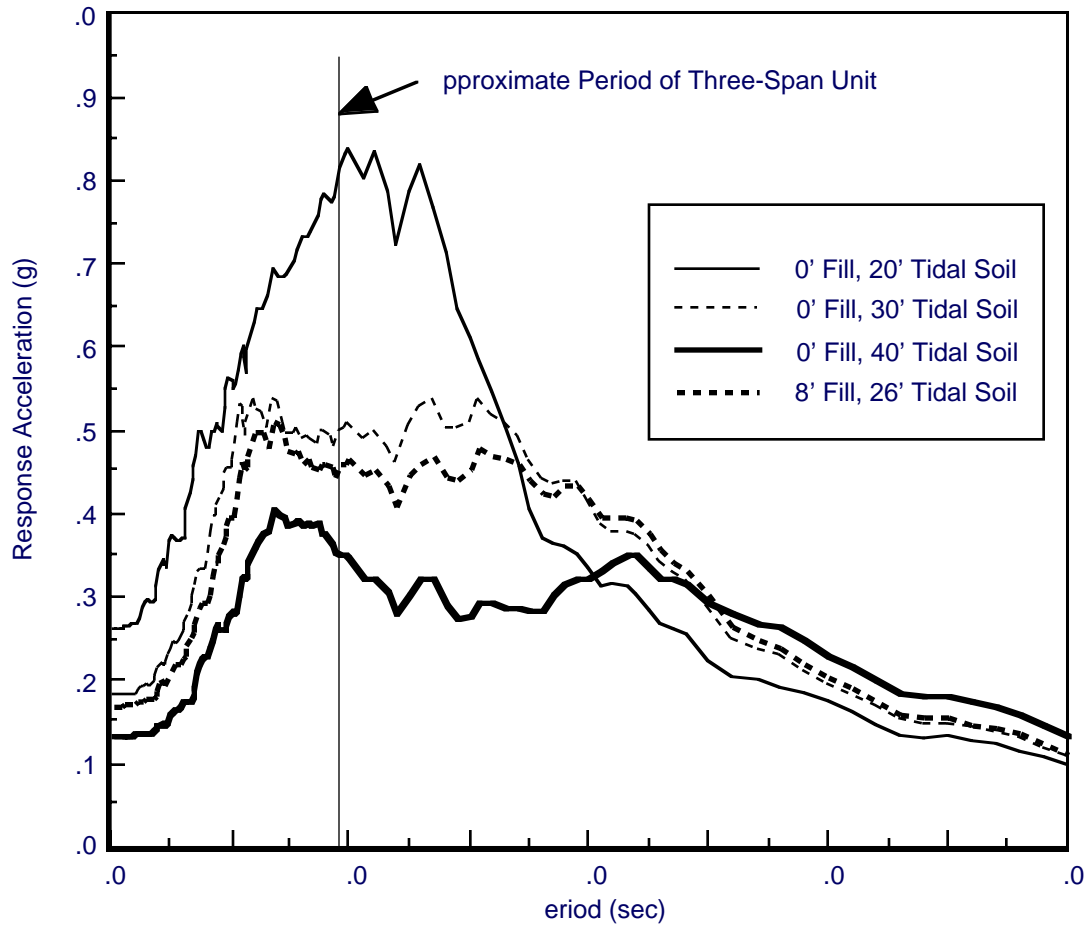
Figure 4. Acceleration Response Spectra

The level of ground shaking at a given site is strongly influenced by the soil conditions at that site. Because soil conditions vary along the length of the Alaskan Way Viaduct, various portions of the viaduct will be subjected to various levels of ground shaking. The viaduct's acceleration levels will likely be highest at locations underlain by 10 to 20 feet of fill; most of these locations are north of about Dearborn Street. South of Dearborn Street, acceleration levels will generally be lower, but larger ground displacements are likely to occur. The variation of the acceleration response for four soil profiles along the length of the viaduct is illustrated in Figure 4.
